**Flood Control Project Maintenance
Levee Inspections**
LMA District Cover Sheet
Spring 2013 Levee Inspection Results

Eastern Honcut Creek

Levee Inspection Report By Mile - Spring 2013

Waterway				Bank	Unit Miles	Inspection Start/End	Inspector	
Unit No. 01 Van Tress				Left	1.50	04/16/2013 04/16/2013	Rick Burnett

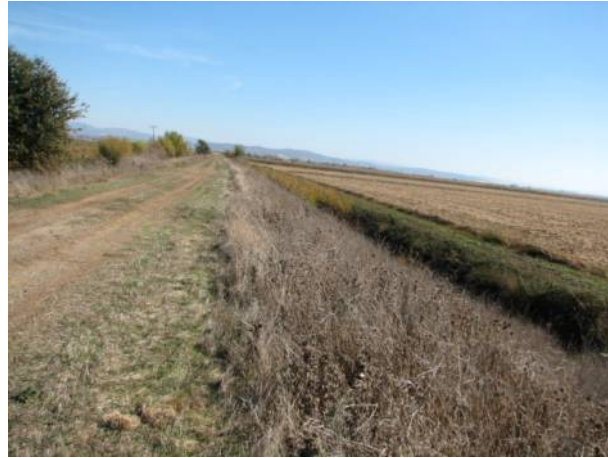
Levee Mile Report Line	5
Start Levee Mile	0.01
End Levee Mile	1.50
Location	Land Side
Category	
Item	Vegetation
This photo shows the landside of the levee at levee mile 0.10.	
jhirabay_s_20130314_033.JPG

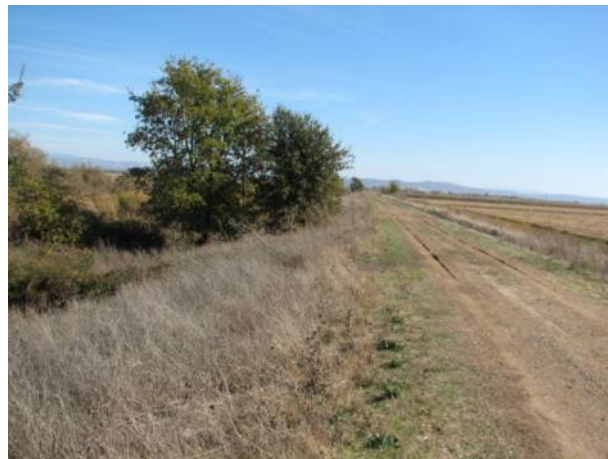
Levee Mile Report Line	6
Start Levee Mile	0.05
End Levee Mile	1.50
Location	Water Side
Category	
Item	Vegetation
This photo shows the waterside of the levee at levee mile 0.10.	
jhirabay_s_20130314_034.JPG

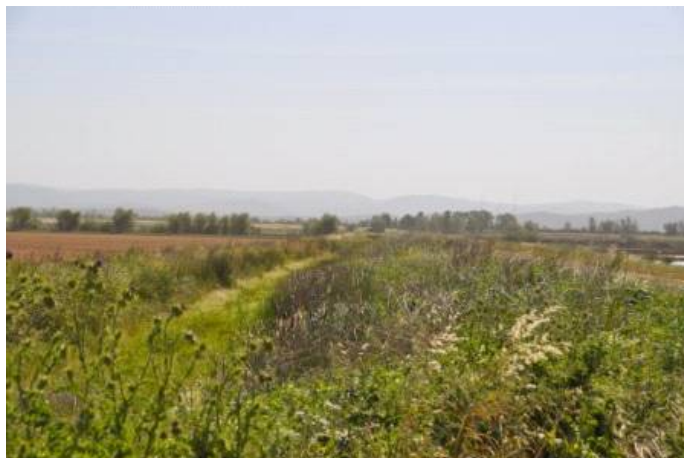
Levee Mile Report Line	7
Start Levee Mile	0.66
End Levee Mile	1.19
Location	Water Side
Category	
Item	Encroachments
Toe ditch parallel to levee @ w/s toe. Heavy vegetation in ditch.	
jhirabay_s_20130314_035.JPG

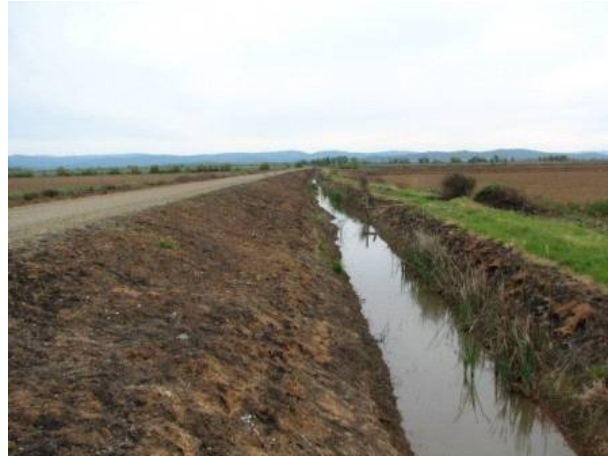
jhirabay_s_20130314_036.jpg

Levee Mile Report Line	8
Start Levee Mile	0.68
End Levee Mile	1.46
Location	Land Side
Category	
Item	Encroachments

Levee mile 0.85, this photo is looking upstream at a ditch on the landside toe.
